Second Letter Report of Test Results of
USATECOM Project No. 8-3-0300-07 F, Product
Improvement Test of Armaltite AR-15 Rifle

Army Infantry Board Fort Benning Ga

14 Oct 63

SUBJECT: Second Letter Report of Test Results of USATECOM Project No 8-3-0300-07 F, Product Improvement Test of Armalite AR-15 Rifle

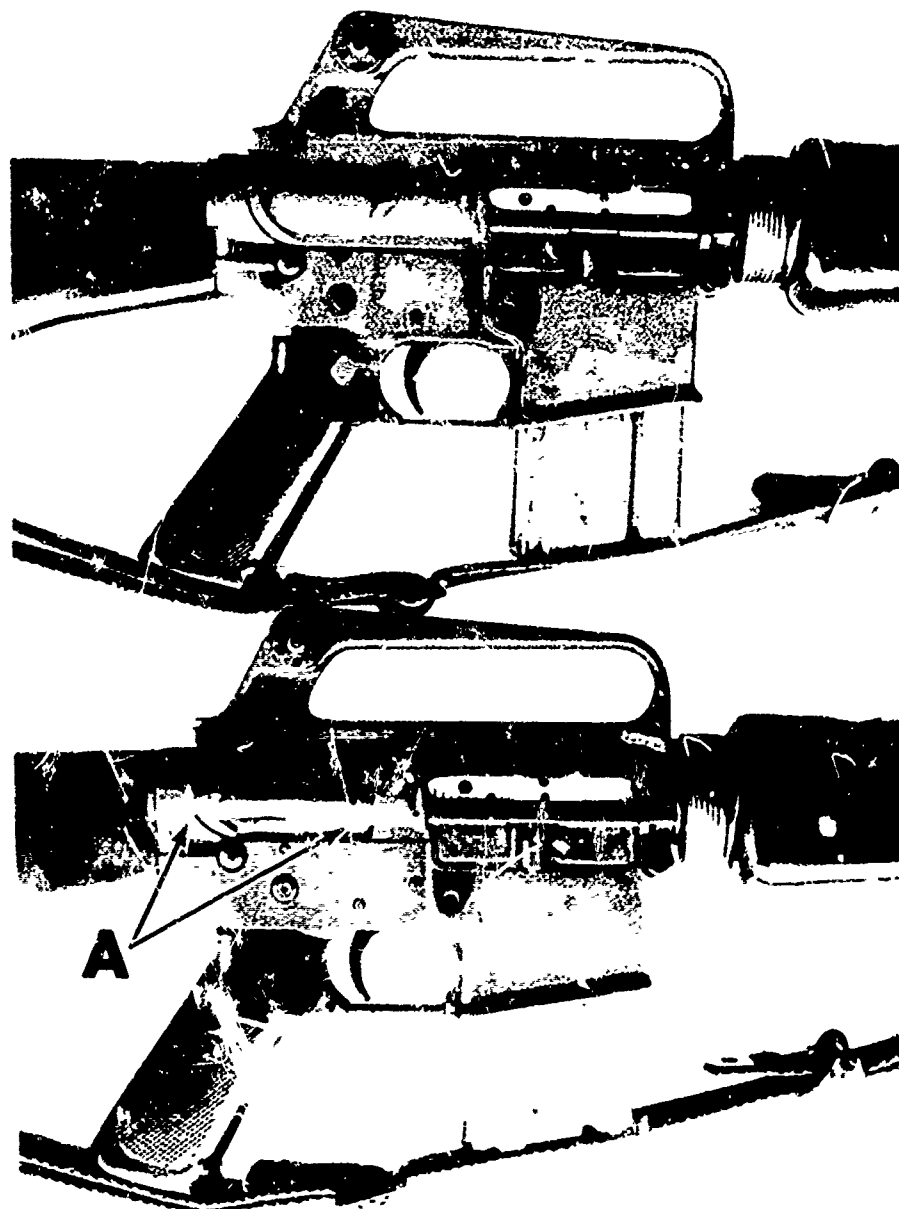
TOP: Receiver of AR-15 rifle as tested in November 1962.
(No bolt assist device)

BOTTOM: Receiver of AR-15 rifle with bolt assist device (A)
mounted on right side. NOTE: The AR-15 rifles
with left side mounted bolt assist device have the
device mounted directly opposite to the one shown.

a. The bolt assist device, mounted on the right side of the receiver as tested, be considered acceptable for bolt closure when the striking surface of the plunger cap is increased in size to provide better striking area.

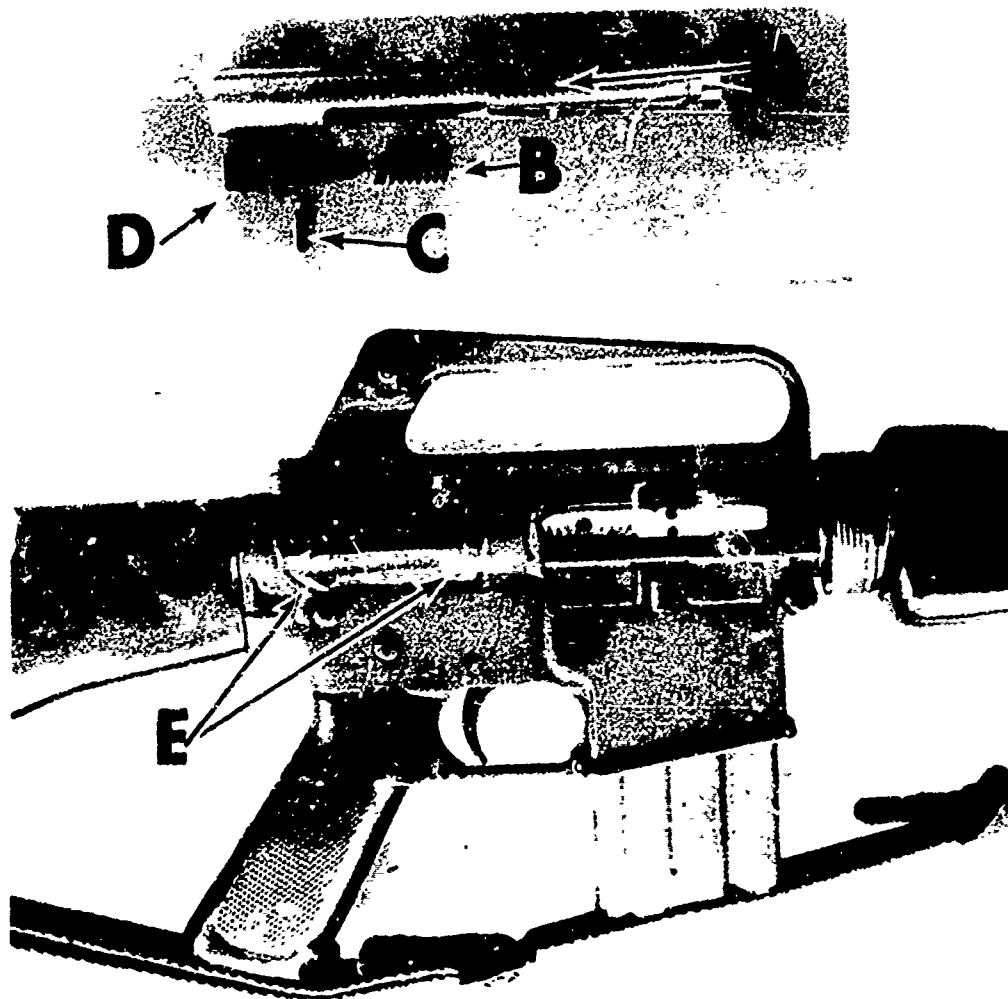
e. During the course of the firing and reloading exercises it was noted that the plunger cap was too small as it caused pain when struck with the heel of the hand (a human factors shortcoming).

Right side mounted bolt assist device:

- A. Bolt carrier with vertical notches.
- B. Return spring.
- C. Retainer pin.
- D. Plunger cap and pawl.
- E. Housing on rifle which encases return spring, retainer pin, and plunger cap and pawl.
